# AUXILIARY FUEL TANKS INSTALLED ON VH-RON

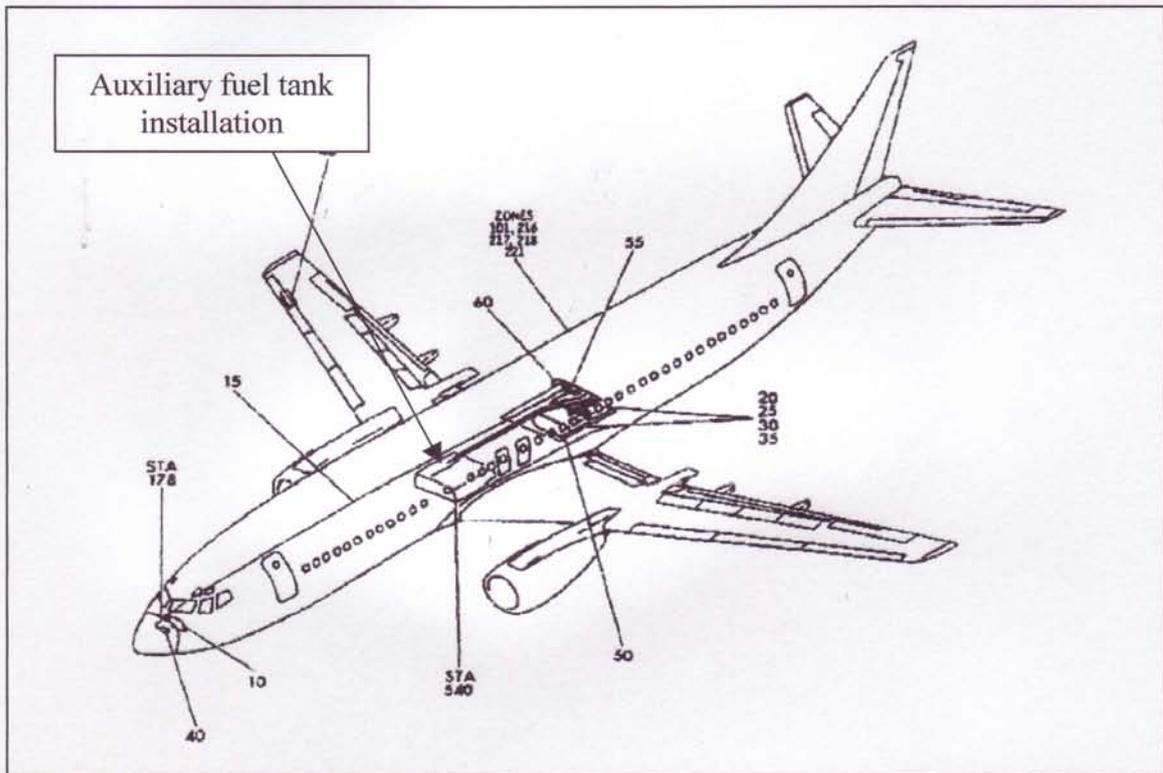
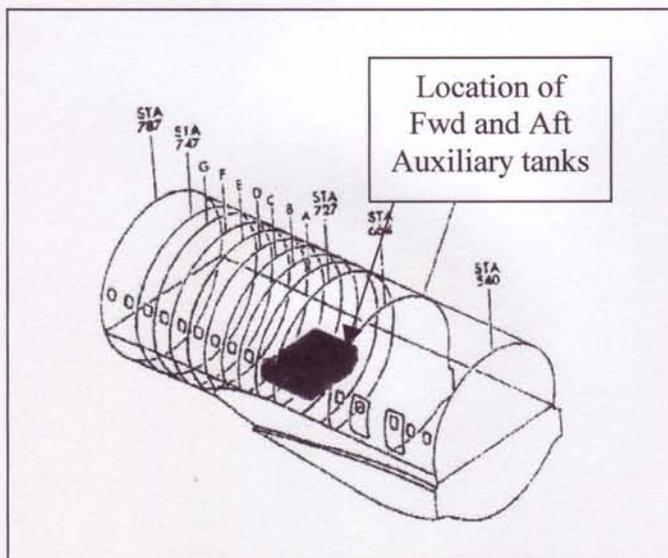
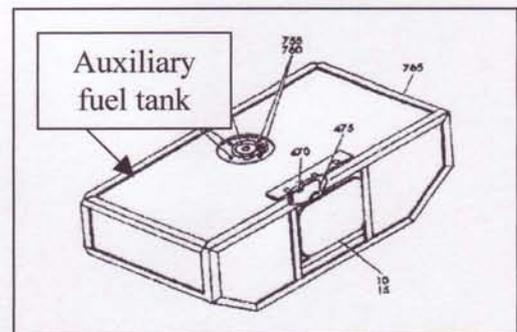
The aircraft is equipped with two auxiliary fuel tanks, which are installed in the fwd section of the aft cargo behind a false bulkhead. Refer to details below for installation locations.

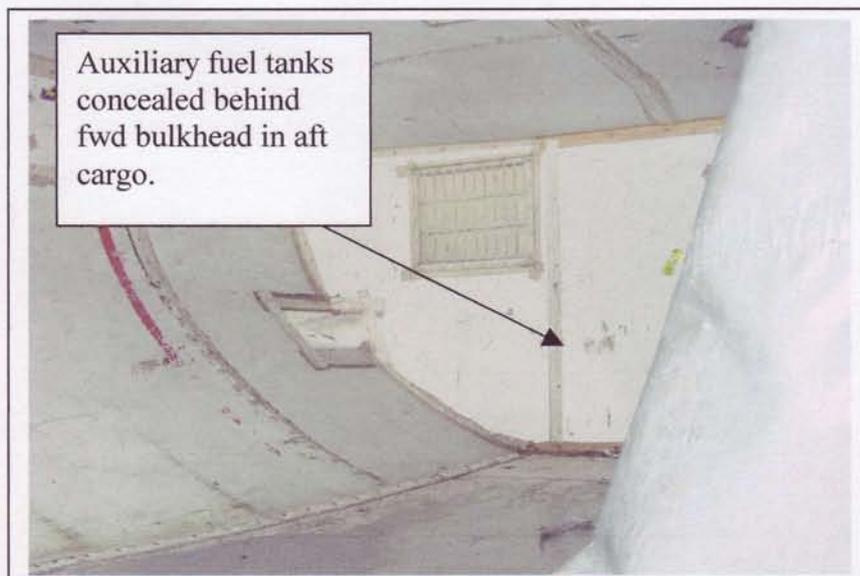
IBA have confirmed that the tanks are installed, however they could not be sighted as the panels could not be removed at the time of the inspection. Refer to detail below.
